**Design quality of  
Scottish schools**

Prepared for: Cathy MacGregor  
Auditor  
Audit Scotland

15<sup>th</sup> November 2007

Client report number 235884

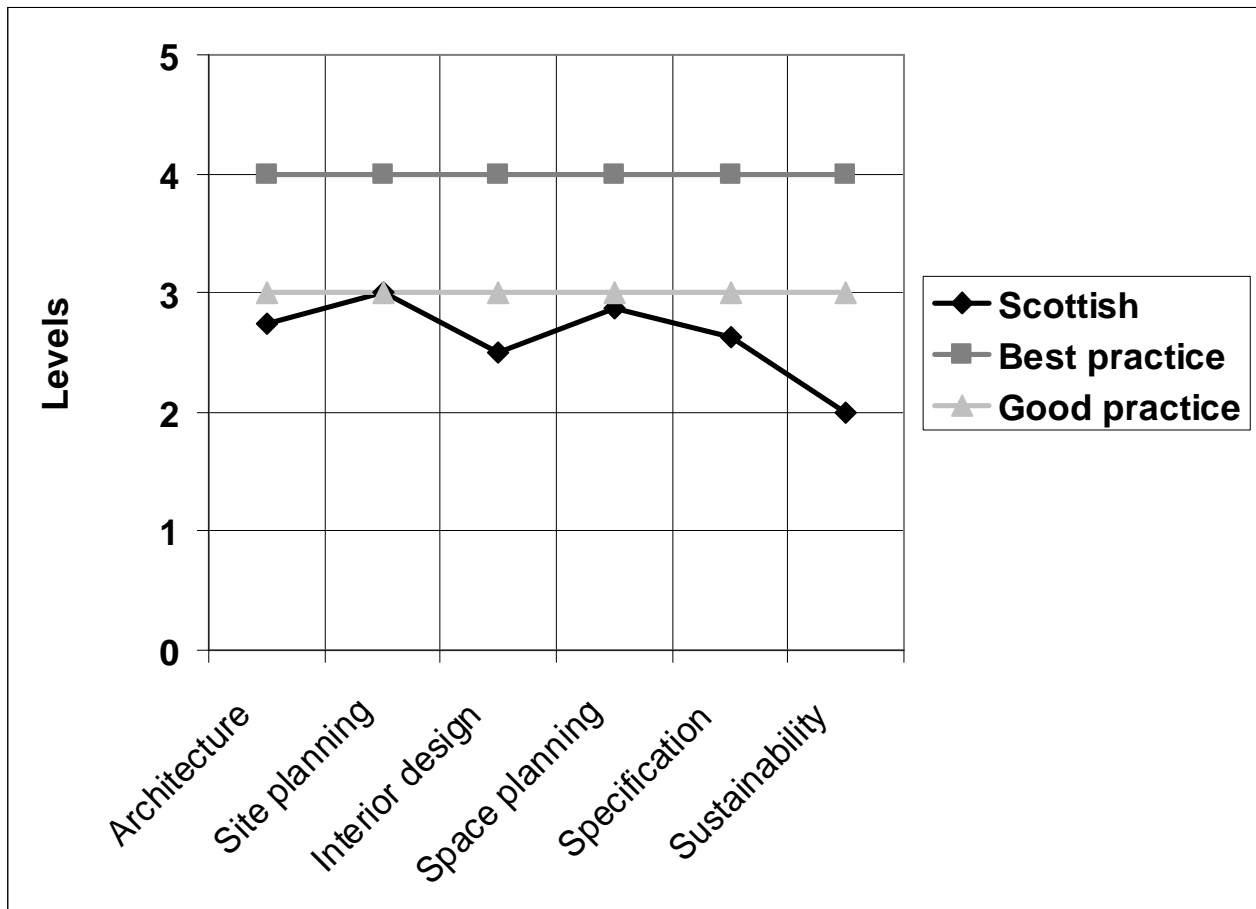
### 3.2 Matrix 1 – Architecture matrix

Site planning and space planning are at good practice levels. Environmental sustainability is at Level 2, an entire level below good practice. Specification and interior design are other areas of concern, but the poor quality of some of the refurbishments is dragging these aspects and architecture (exterior) down.

There was marked evidence of the implementation of comfort-cooling in certain areas such as computer rooms and libraries – given the trends above, users will increasingly perceive the need for increased mechanical ventilation or even air conditioning, rather than passive means, to furnish them with a well-tempered educational indoor environment that is fit for purpose.

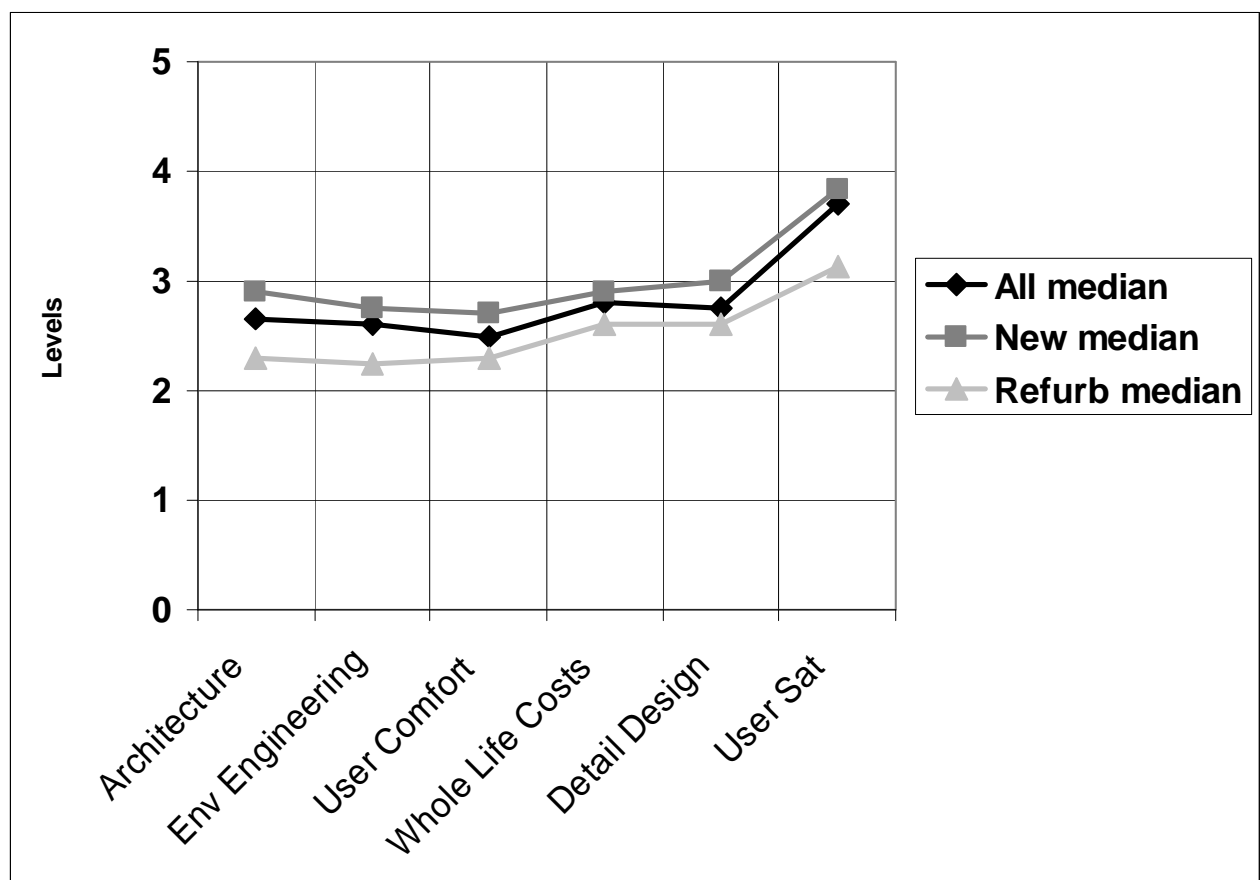
### 4.1 New build compared to refurbishment

This matrix clearly shows the disparity between the design quality of new build schools as compared to refurbishments. Refurbishments, regardless of the procurement route used, were significantly below good practice across the board. And this is anecdotally corroborated by the difference of nearly an entire level recorded by the users of these schools. There were some extreme examples which reduce the level of the overall median of refurbished schools, however they were all below good practice overall. There were in some cases examples of the refurbishment making some aspects of the schools worse – particularly in terms of ventilation caused by sub-optimal new window arrangements. The new windows were obviously double-glazed replacements for single-glazing, but almost always entailed fewer opening lights in a less than competent arrangement.

The overall trend among the refurbished schools was the prioritisation of Disability Discrimination Act (DDA) compliance. While this is laudable and legally necessary, it often entailed elaborate and expensive retrofitting of thirty or forty year old schools to make them fully accessible. In one case, the refurbishment seemed to consist almost solely of installing a lift to make a four-storey block fully accessible.

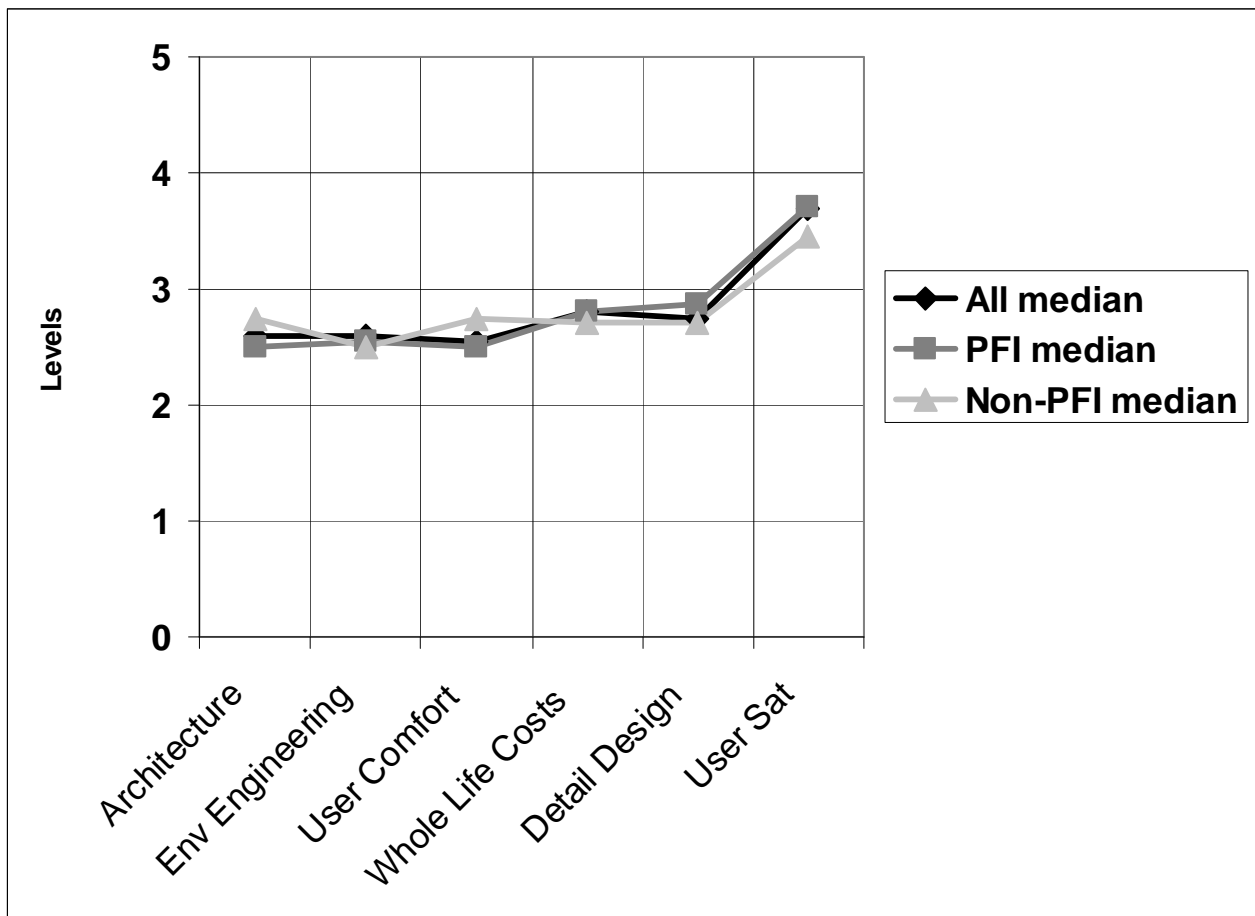
### 4.3 PFI compared to Non-PFI

There appeared to be little difference between PFI and Non-PFI procured schools overall, particularly in regard to the refurbishments. The median of the overall sample is just below good practice, although there were a minority of schools that approached best practice in some aspects and some schools considerably below good practice overall.

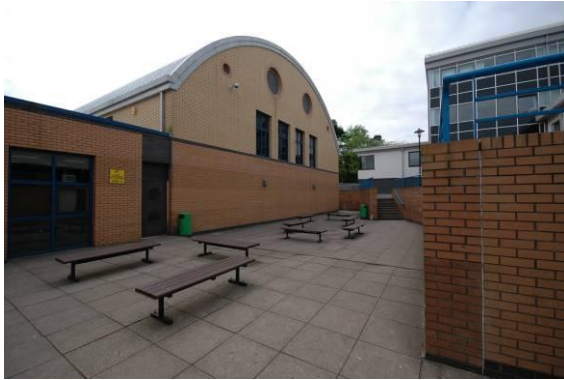
Constrained and confusing site layout

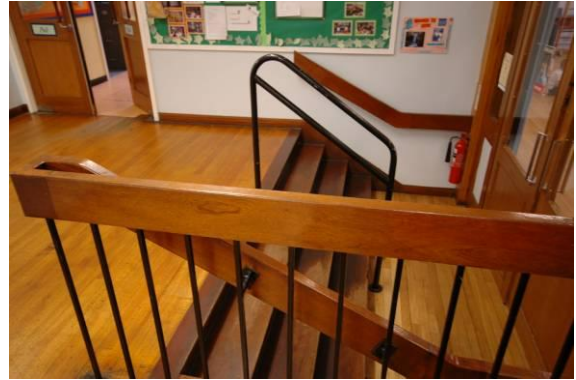
Ground floor inaccessibility to assembly hall

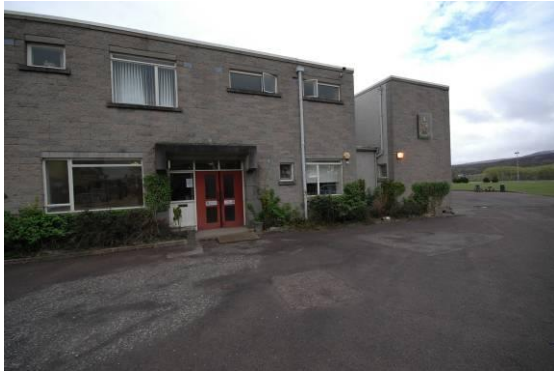
Poorly-proportioned entrance lobby

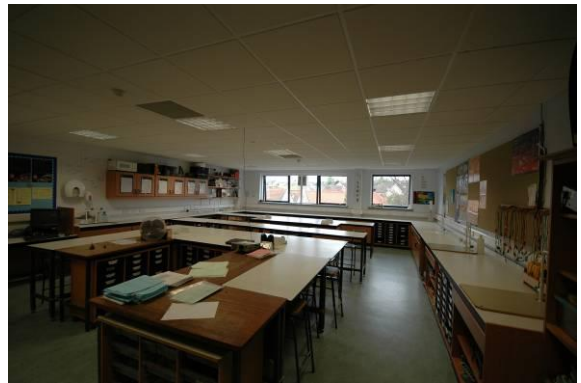
Poorly-proportioned classroom

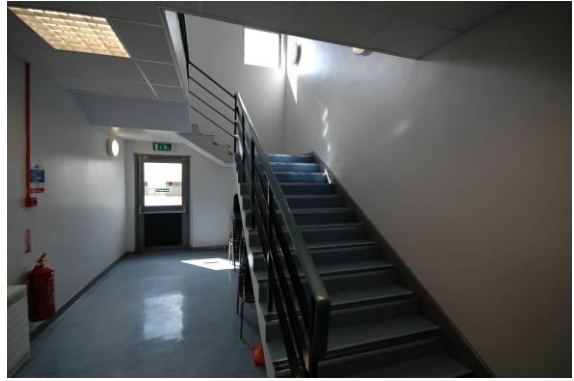
Restricted headroom – less than 2 metres

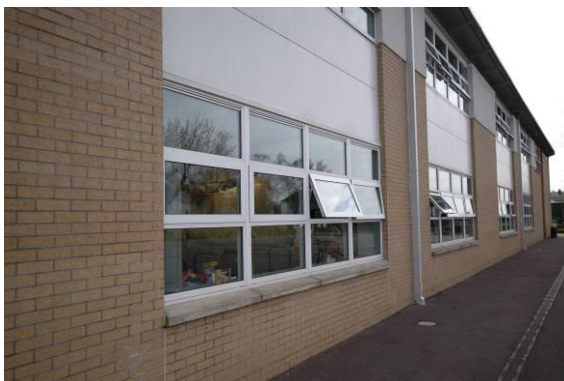
The ventilation of teaching spaces was usually poor due to sub-optimal opening-window arrangements which usually consisted of a single row of opening windows in the horizontal centre of the window arrangement – rather than the optimal top and bottom opening-window arrangements. It seems that ventilation arrangements in many refurbished schools were made worse with the introduction of double-glazing with fewer opening windows, in a sub-optimal arrangement as described above. Presumably, a commercial decision was made to specify fewer opening-windows than the original and traditional, albeit single-glazed, arrangements. The best classroom configuration dated from the 1950s, with a high ceiling height (about 4 metres); low and high level opening windows with cross-ventilation to the corridor; and thermally-heavyweight construction.

Poor opening window arrangement

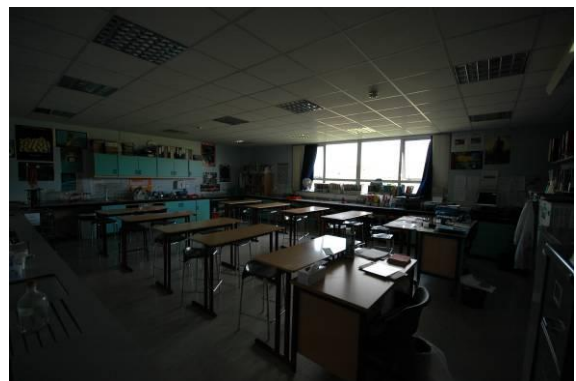
Poor glazing ratio to classroom

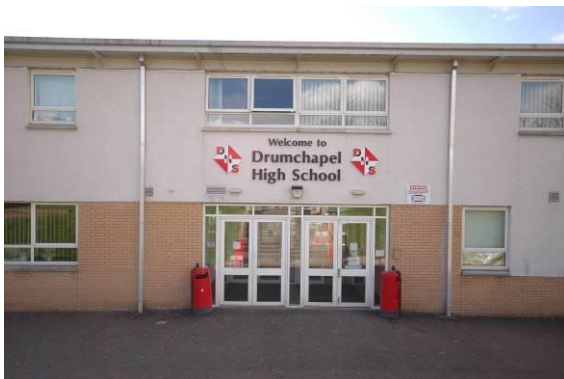
Low-key entrance only signified by signage

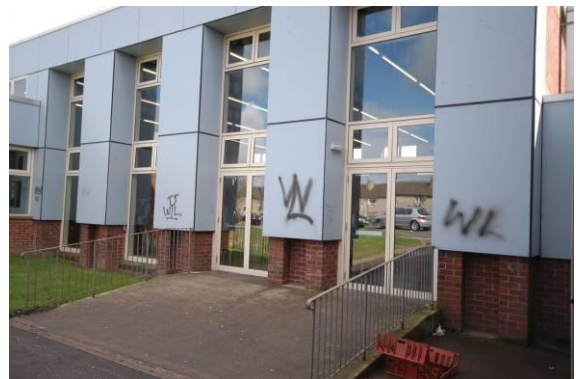
[Smooth low level cladding encourages graffiti\\*](#)

*[\\*a roughly textured finish such as brickwork at low level would be more difficult to vandalise.](#)*

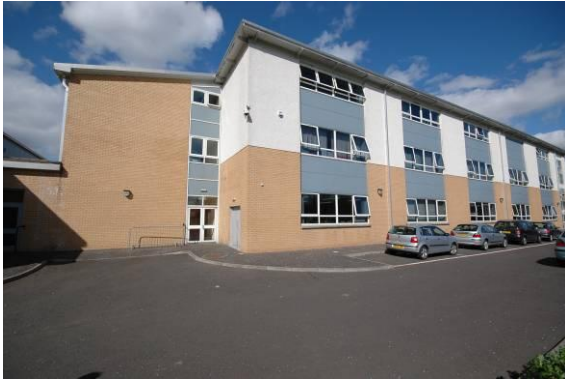
Lack of civic presence – office block?

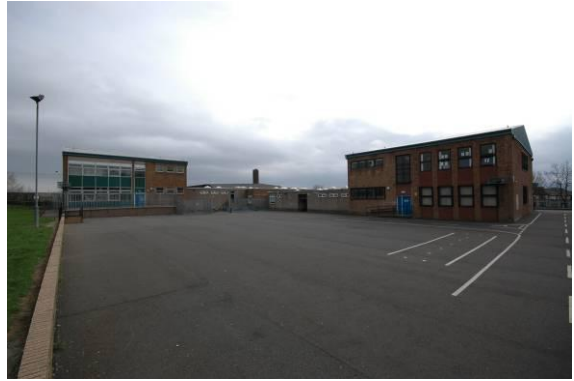
Unimaginative hard surfacing

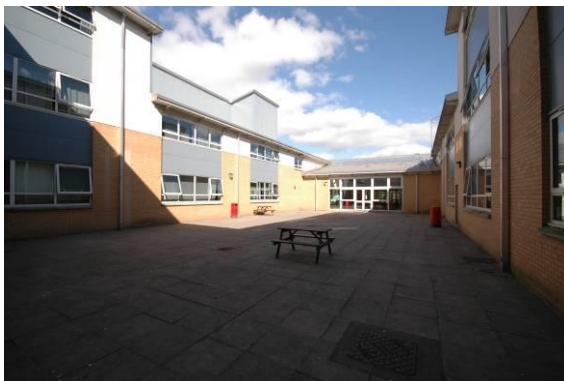
Mean and hard-surfaced courtyard

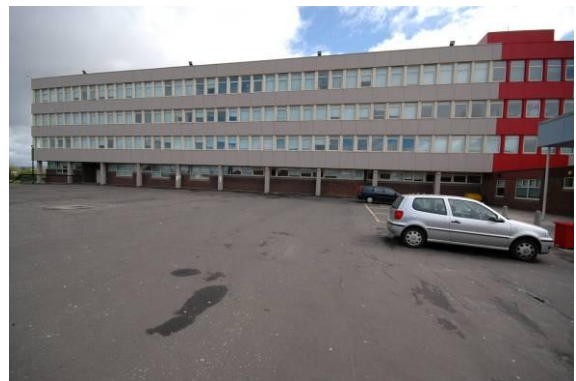
Extensive tarmac foreground to school entrance

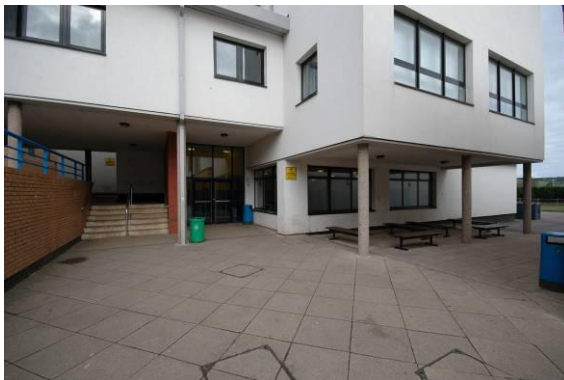
Constrained and confusing site layout

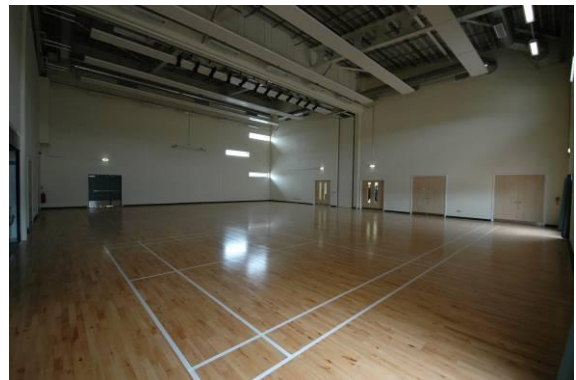
Sports hall with minimal daylighting

5. **Sports halls** tended to be black-box, or with minimal daylighting. Lighting was needed during occupancy, but many instances were found of lights-on (except for safety lights) with prolonged nil-occupancy. When property design personnel were present, almost all were unaware of the Sport Scotland guidance that recommends north-light roof construction and wall colours to enable good vision of shuttlecocks and balls.

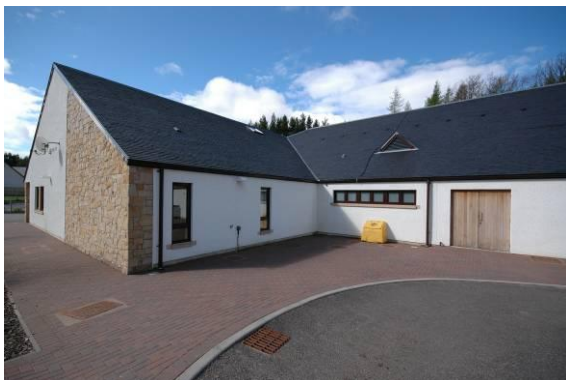
Exotic roofing slates in the Highlands

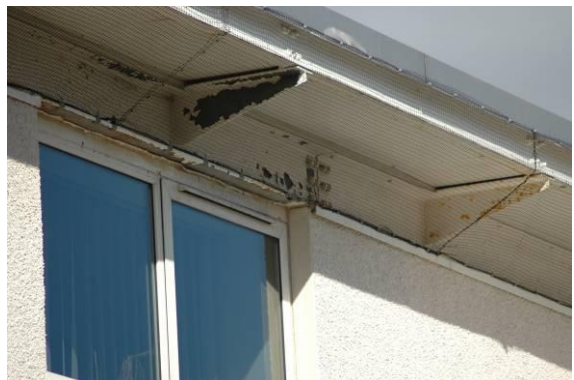
Poor detailing to roof eaves

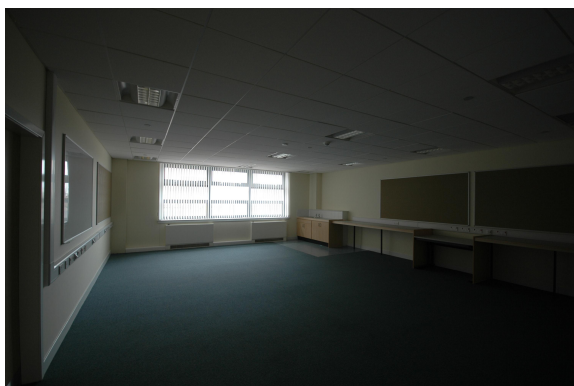
Poor natural daylighting - more electric lighting

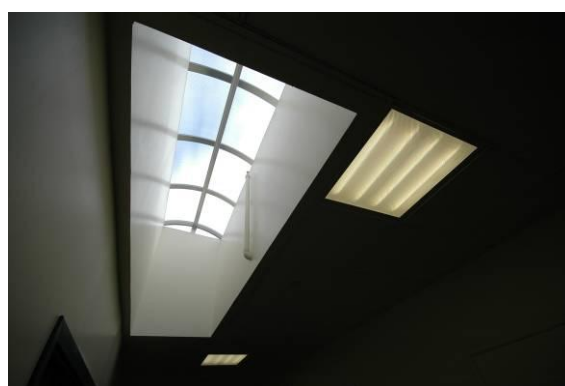
Fixed rooflights do not encourage natural ventilation

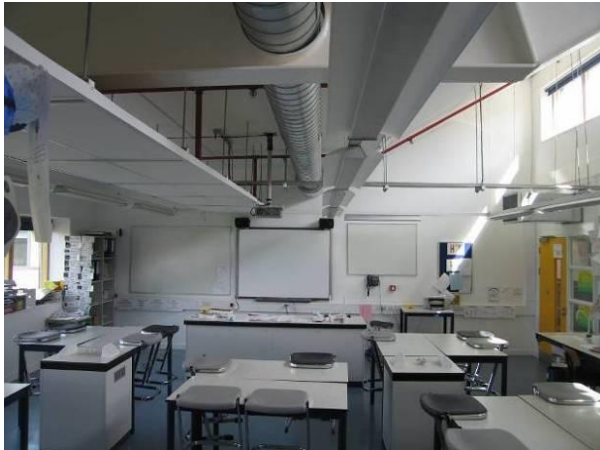
### Whitecross School, Hereford – ideal natural lighting conditions in a classroom

Typical classroom – ideal daylight conditions

Ideal range 30-300 Cd/m2

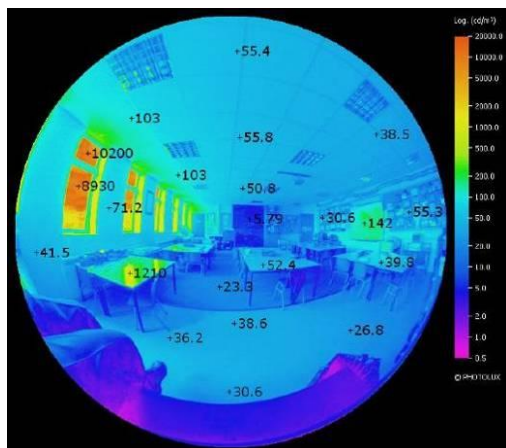
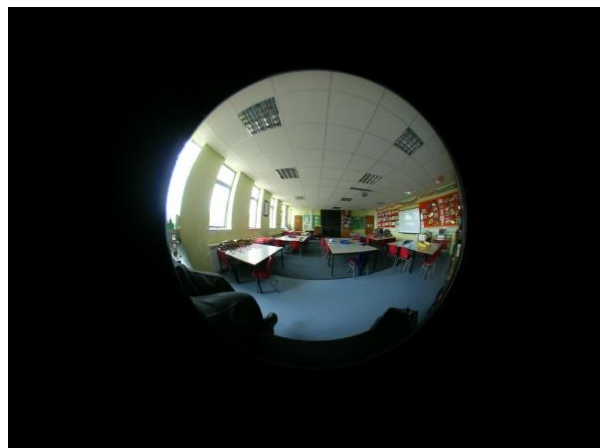
### Good Practice daylight to classroom

Note the room fabric brightness levels are mainly within the preferred  $30Cd/m^2$  to  $300Cd/m^2$  range. This room has little need for artificial lighting on the majority of days.

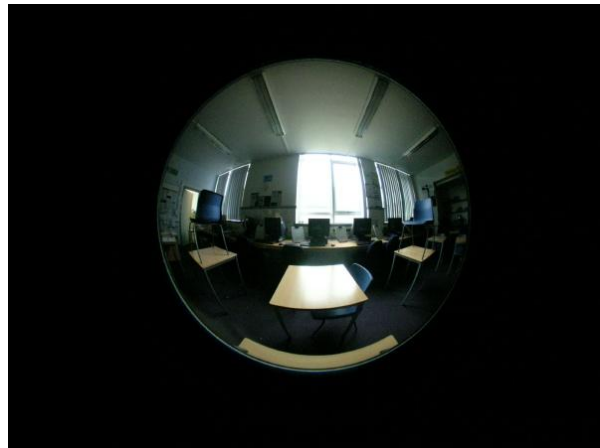
### Bad Practice daylight to computer room

The daylight from the window is a major source of glare. The glossy table-top has a brightness from window glare that will very effectively cause unacceptable glare with the prime visual field for anyone working at that table.

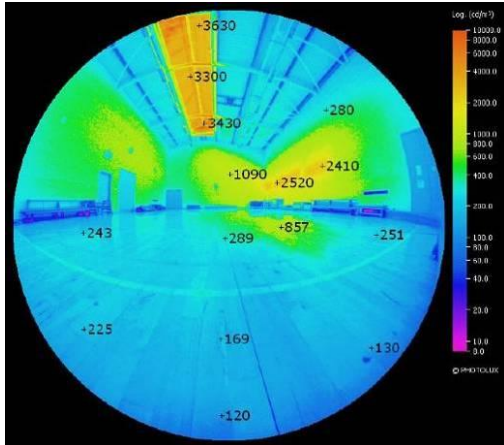
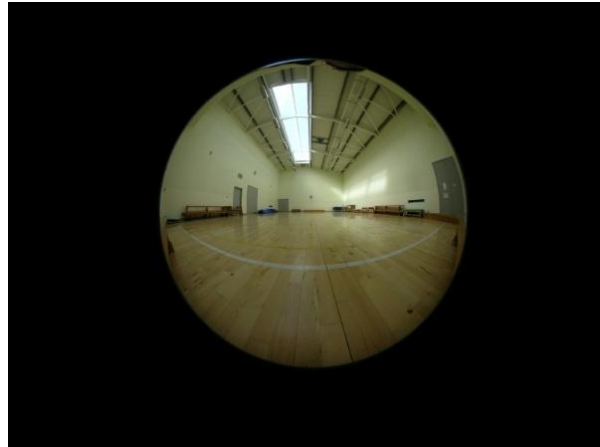
### Good Practice daylight to sports hall

Very even daylighting at an entirely adequate level. Note that if fabric colours (wall and ceiling) were to Sport Scotland recommendations, the overall brightness levels would be 20% to 30% down, and would warrant additional daylight.

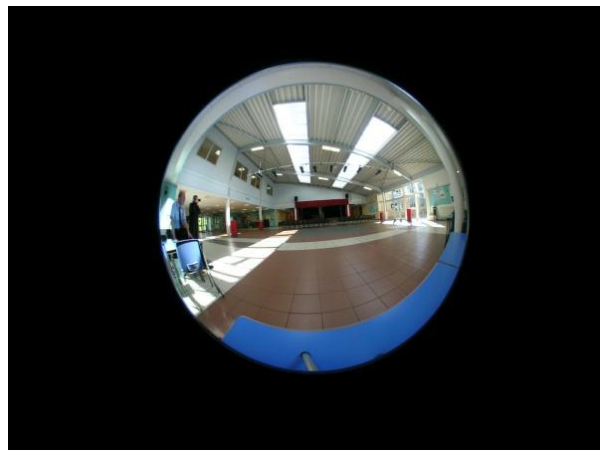
### Good Practice daylight to dining hall

This dining hall has extensive daylight from the rooflights. This provides a bright evenly-lit area that shows the joy of good daylight. Note the artificial lighting is on – at these levels of daylight this will have minimal impact on brightness levels.

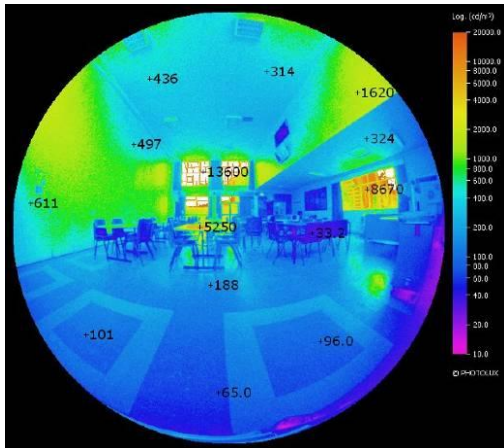
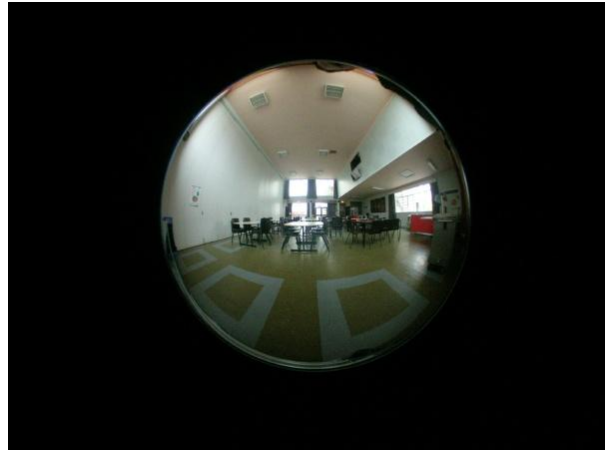
### Good Practice daylight to dining hall

This dining hall is lit from both sides from large high-level windows. The resulting daylight level is more than adequate to displace the need for artificial lighting, and is visually comfortable. This school dates from 1970.
